New York State Department of Transportation

Yellow Flag NB23U4W013

BIN: 1065318

Location: Span 256 G4 at Pier 256

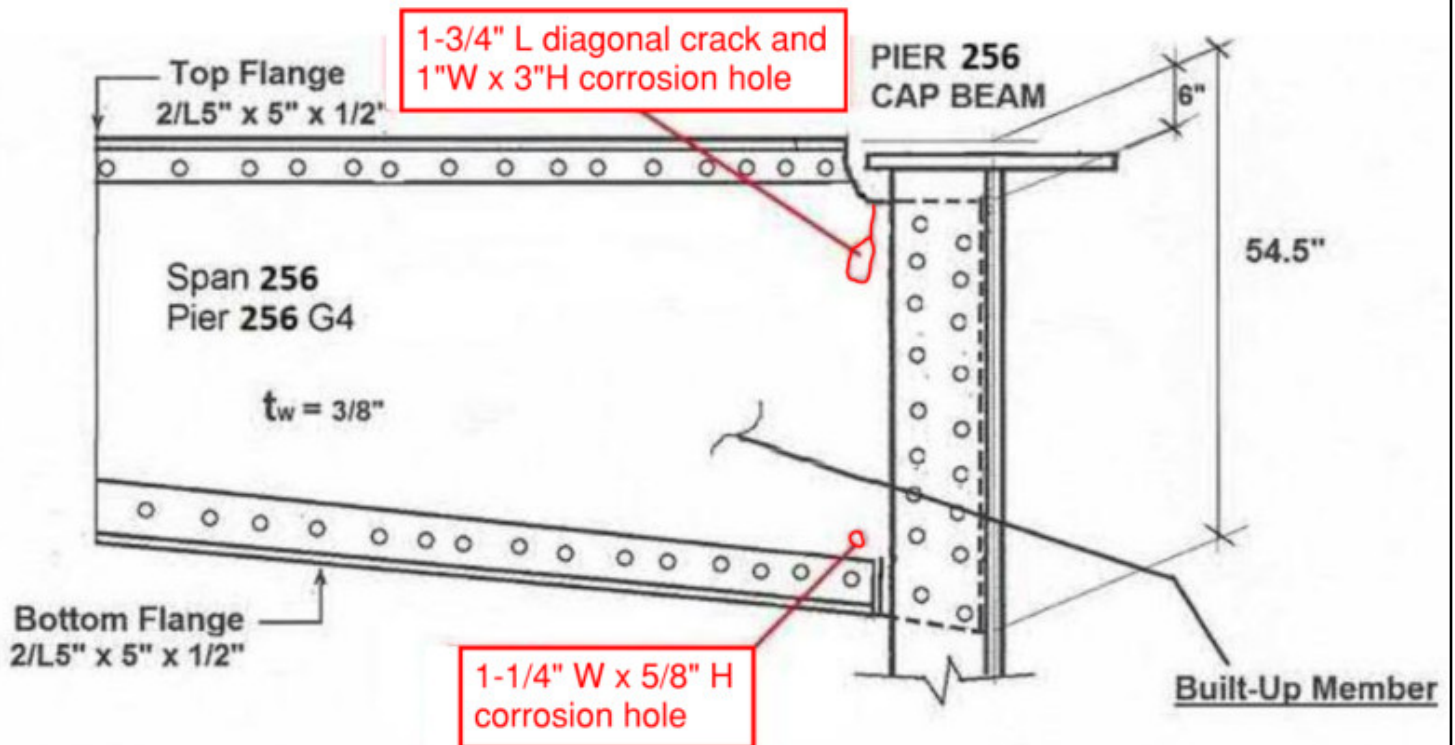
Photo Number: 2

1. Additionally, the right side web of Girder G4 exhibits a 1'-8"L x 1" to 2"W area with 1/8" to 3/16"D section loss at the top web along the connection angle. The lower web exhibits a 1'-6" x 1'-6" area with 1/16" to 1/8" pitting. Surrounding the hole in lower web, the web exhibits a 5" x 5" area with 1/8" to 3/16"D section loss. The left side web of Girder G4 exhibits a 3"W x 6"H area at the cope with 1/8" to 3/16"D section loss. The lower web exhibits a 5"W x 8"H area with 1/8" to 3/16"D section loss adjacent to the connection angle. See sketch for details.

Built-Up Member Properties

Vary depth web: 54.5" b-to-b Ls @ Piers 255 and 256 and 33" @ midspan

Web thickness = 3/8"

Bottom and Top Flanges are two equal leg angles L 5" x 5" x 1/2"

SKETCH FOR YELLOW # NB23U4W013
SPAN 256, GIRDER G4 AT PIER 256
(LOOKING LEFT)
N.T.S

Attachment Description: Flag Condition Sketch

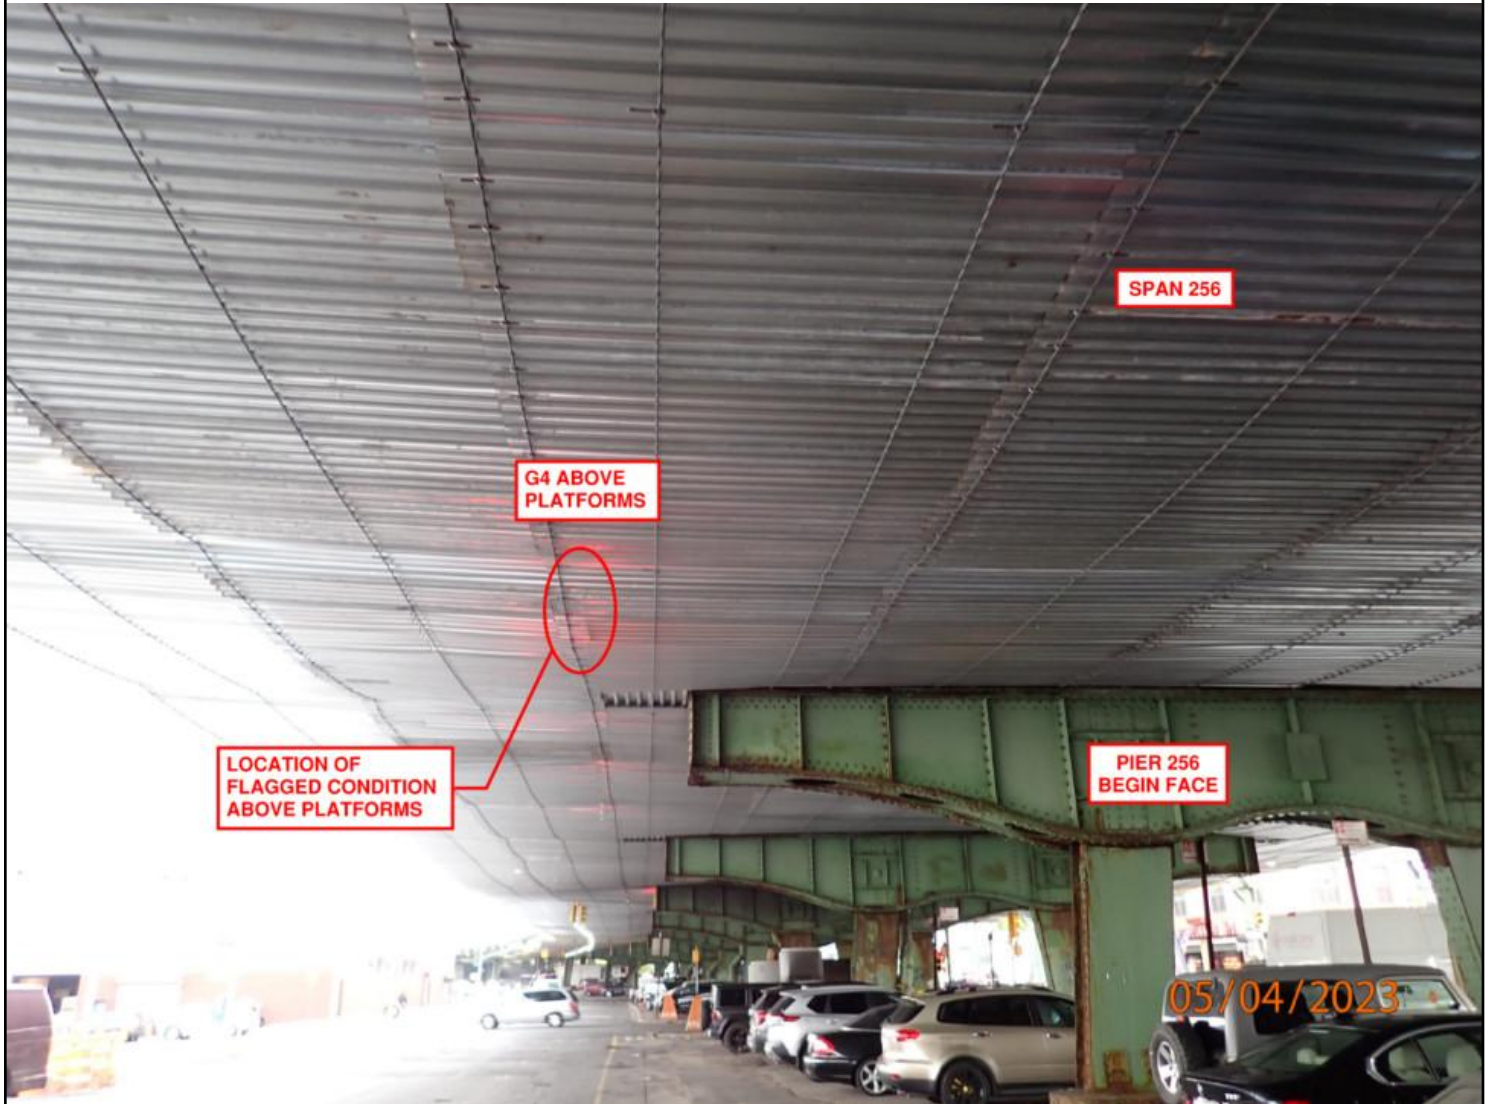
Photo Number: 3

Attachment Description: General View of Flag Condition Location. Looking End.

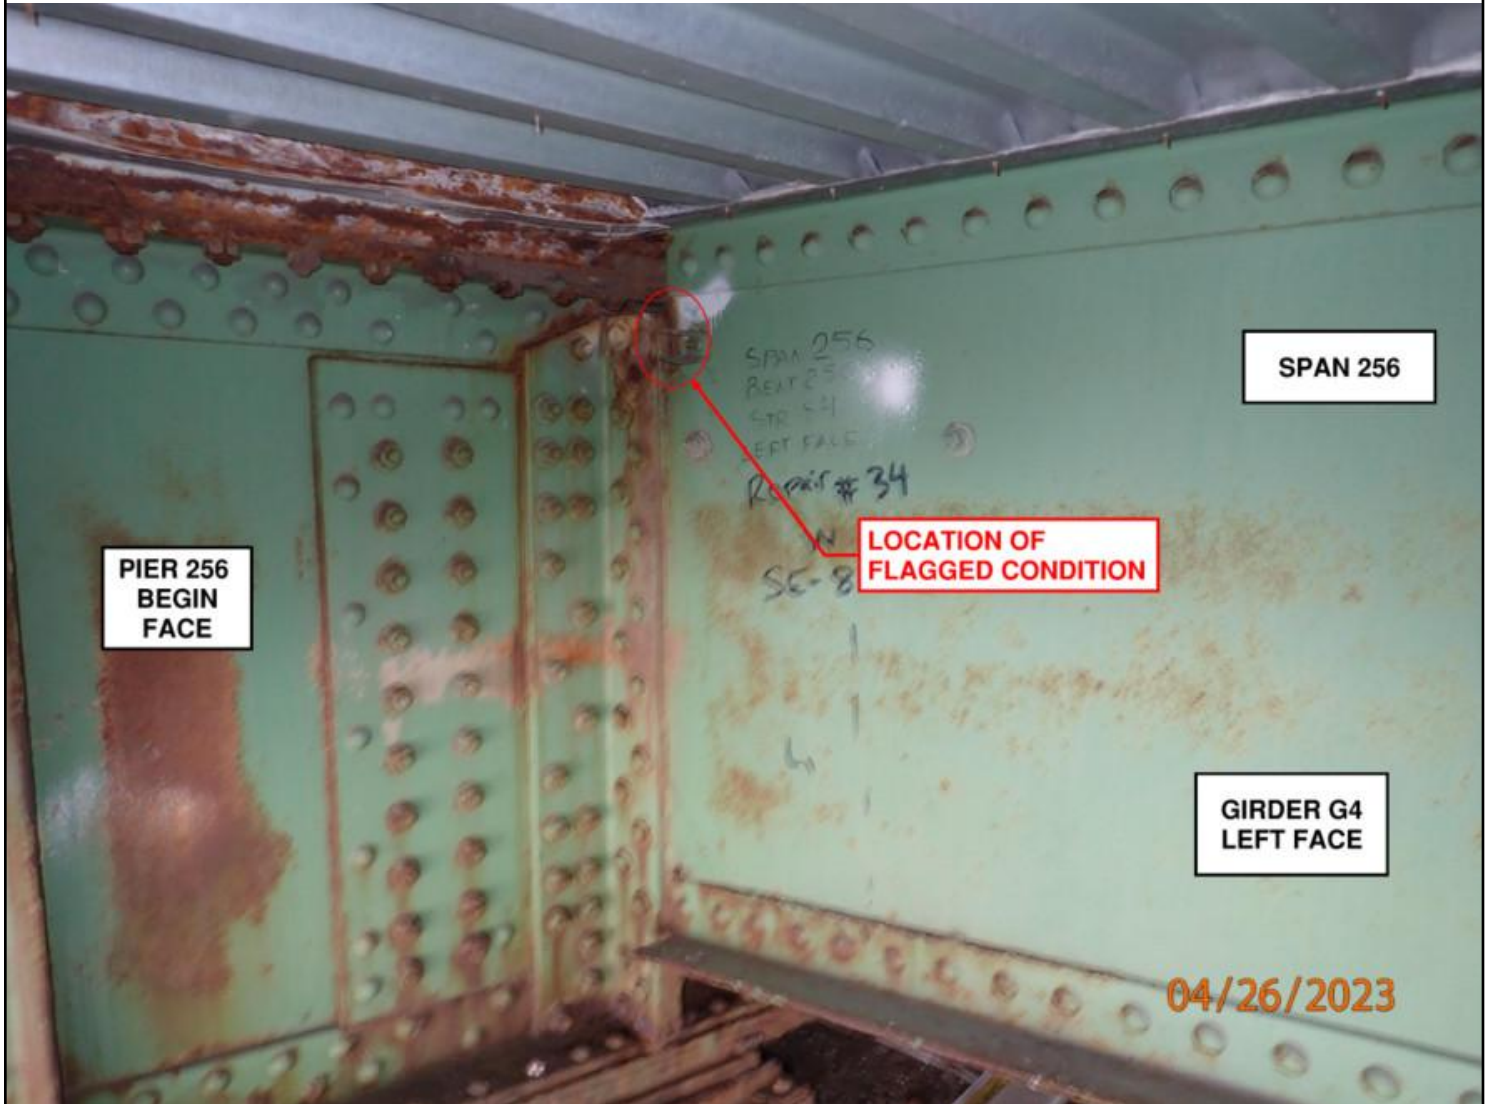
Photo Number: 4

Attachment Description: General view of Girder End with flagged location. Looking End Right.

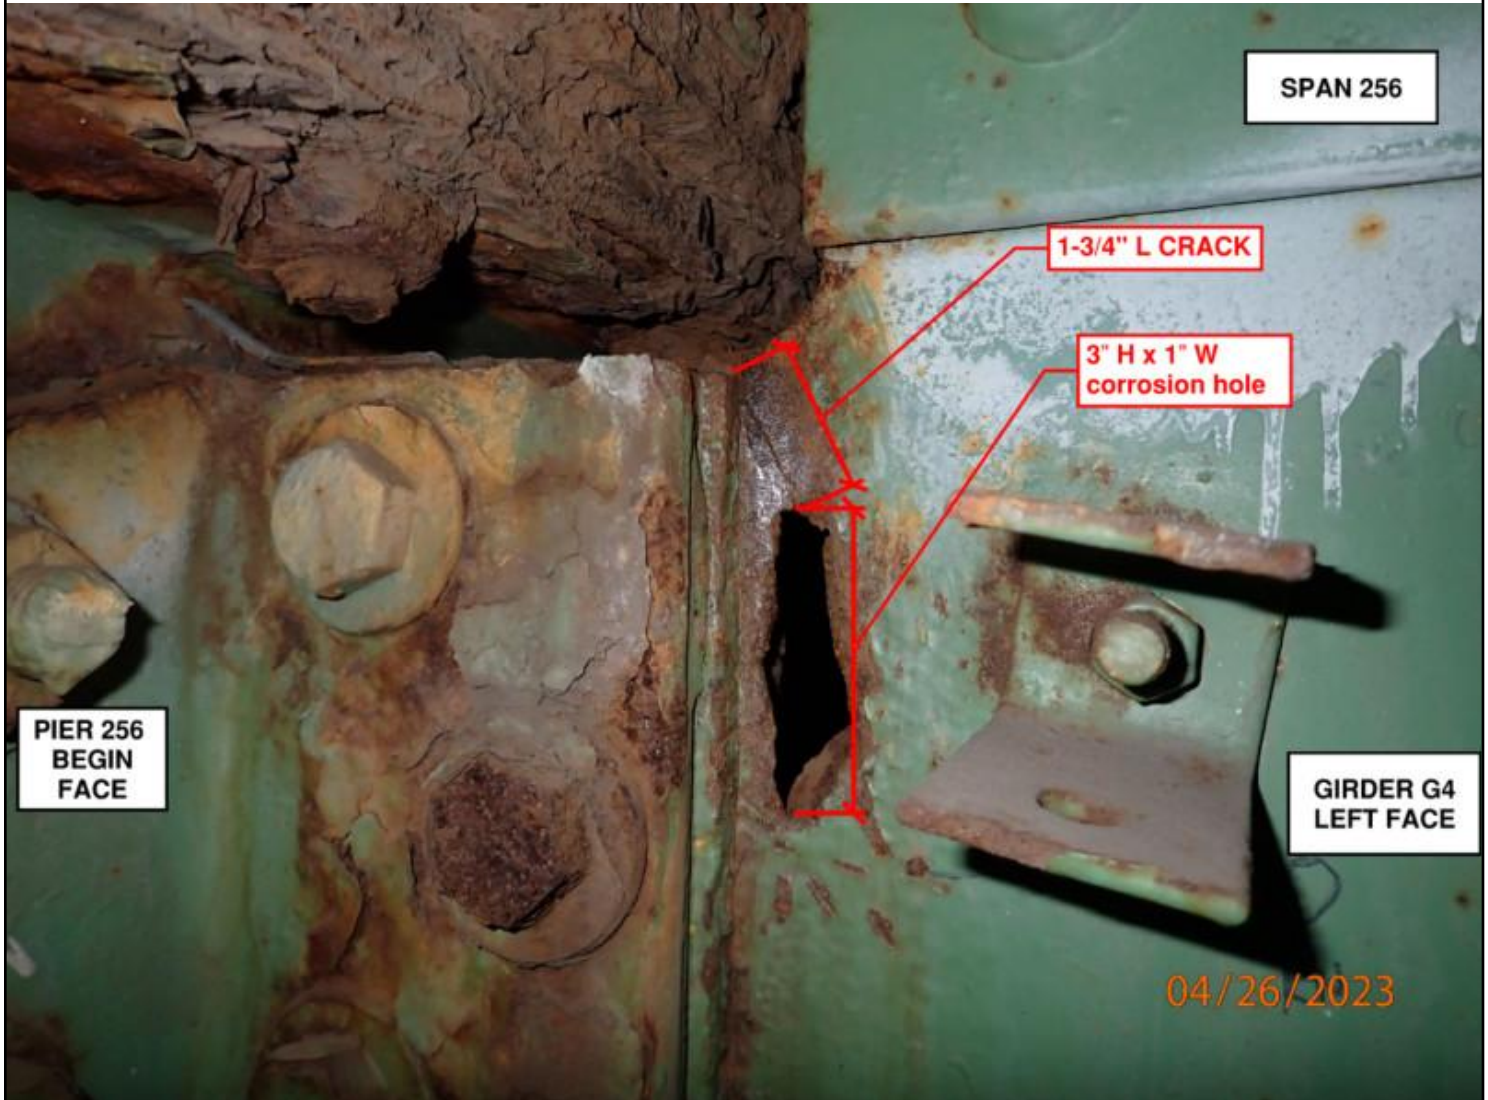
Photo Number: 5

The girder web at the upper cope exhibits a 1-3/4" long diagonal crack that extends into a 3" H x 1" W corrosion hole (same as previously noted). The lower web above the bottom flange angle vertical leg has a 5/8"H x 1-1/4"W corrosion hole. (previously noted as 1" W x 1/2" H diameter corrosion hole).

Attachment Description: Span 256 G4 at Pier 256 – Close up view of 1-3/4" long diagonal crack at upper cope and 3" H x 1" W corrosion hole at end of crack. Looking End - Right.

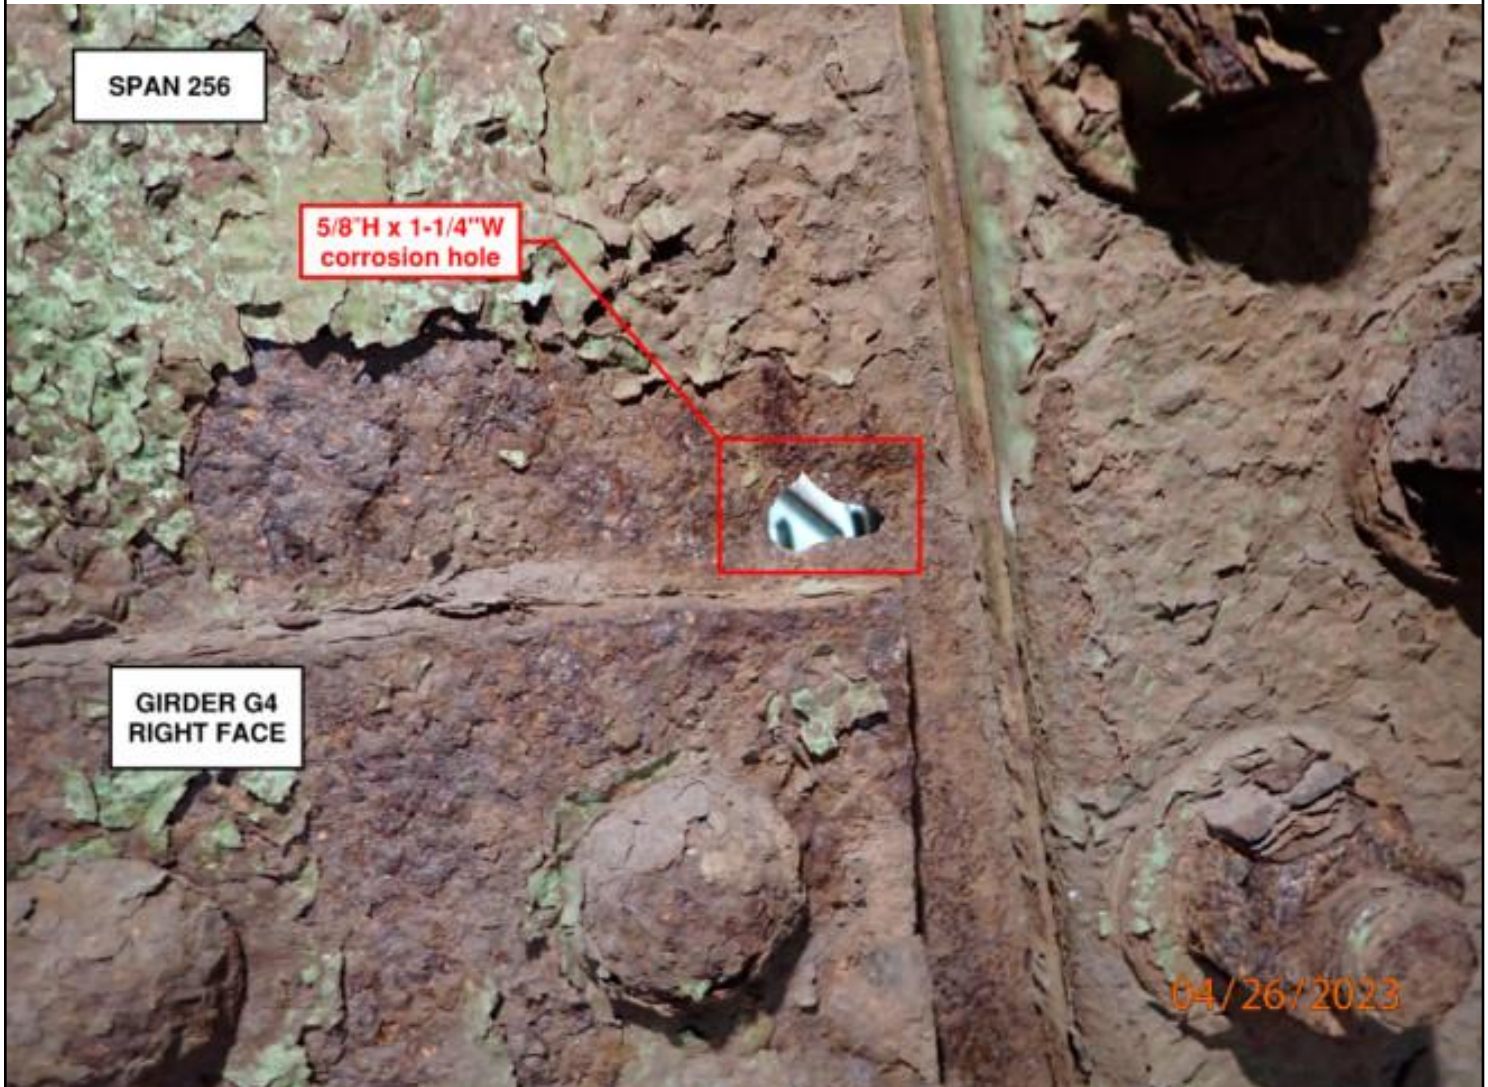
Photo Number: 6

Attachment Description: Span 256 G4 at Pier 256 – Close up view of 5/8"H x 1-1/4"W corrosion hole at lower web above bottom flange angle. Looking Left.
